LAKE VICTORIA BASIN
Integrated Water Resources Management

Kagera river outlet sediment plume

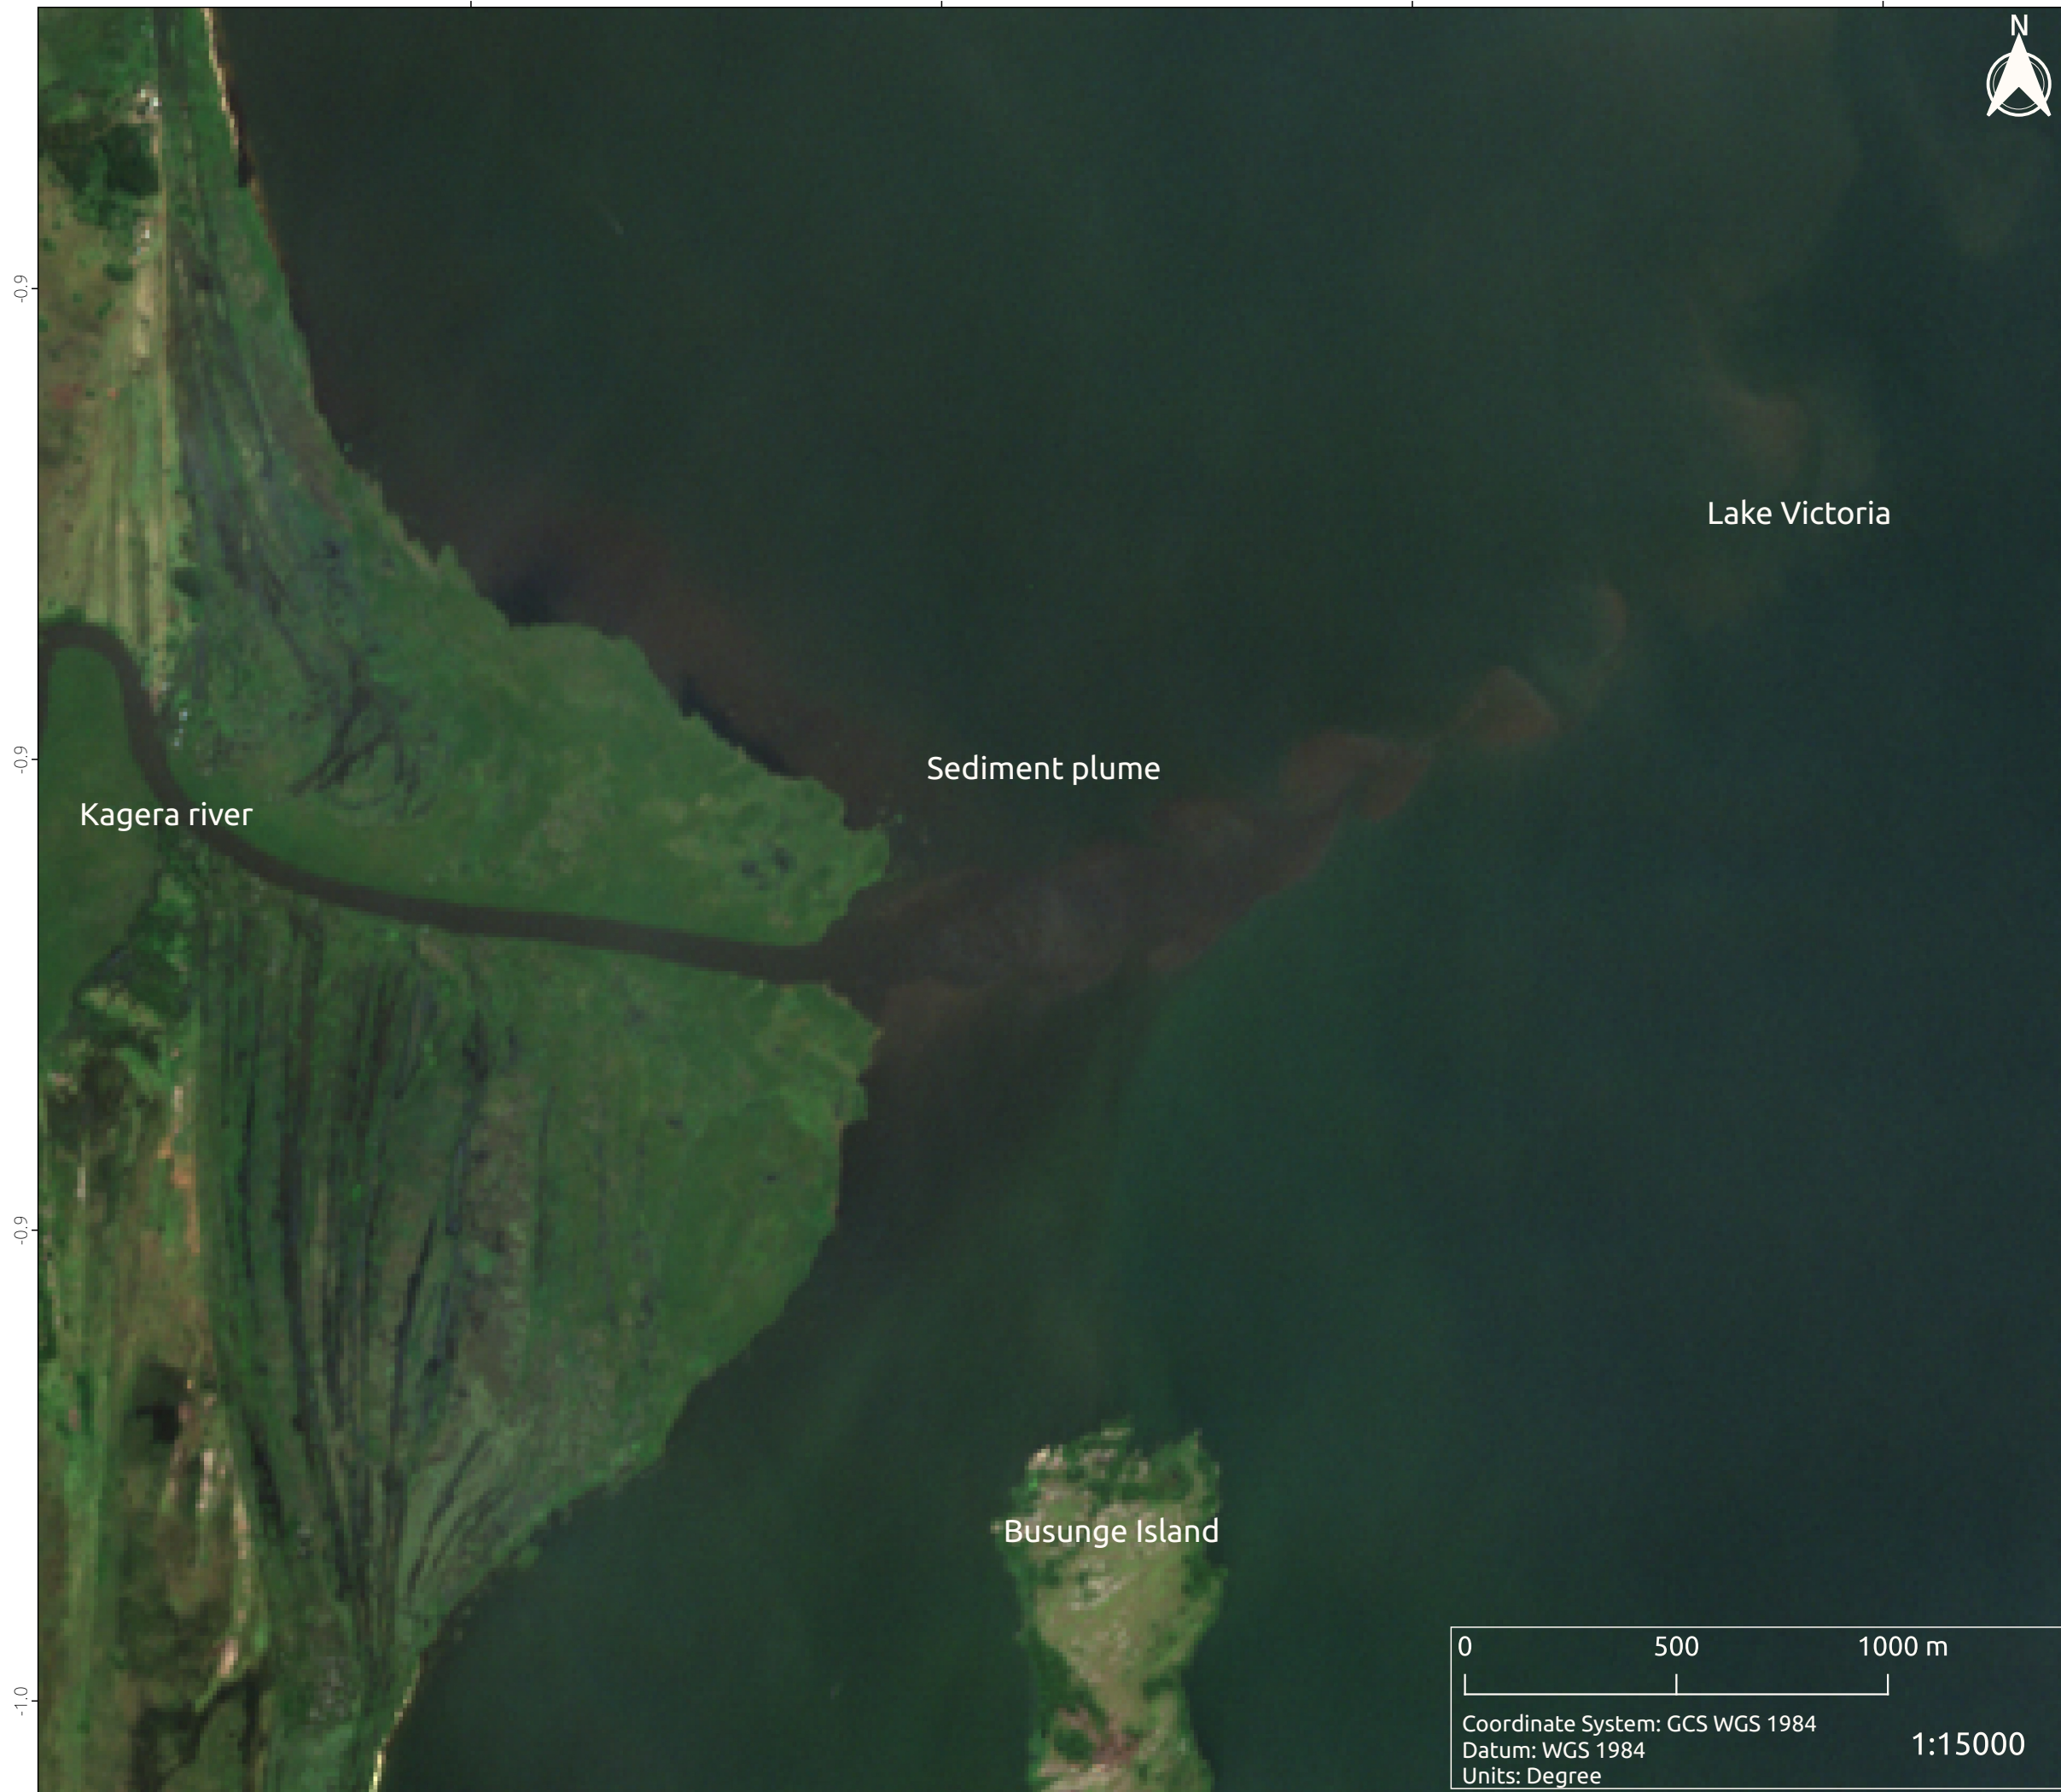
Map Code: 20221013 IWRMP KA TC Sent 2 May 2021 Map

These maps depict Kagera river sediment plumes during various time steps in 2021. The true colour (TC) images are derived from Sentinel 2 satellite datasets. Sediment can carry pathogens, nutrients and other detrimental substances for the water quality of Lake Victoria.

Sentinel 2 TC Image May 2021
