Nzoia river outlet sediment plume

These maps depict Nzoia river sediment plumes during various time steps in 2021. The true colour (TC) images are derived from Sentinel 2 satellite datasets. Sediment can carry pathogens, nutrients and other detrimental substances for the water quality of Lake Victoria.

Map Code: 20221013 IWRMP NZ TC Sent 2 July 2021 Map

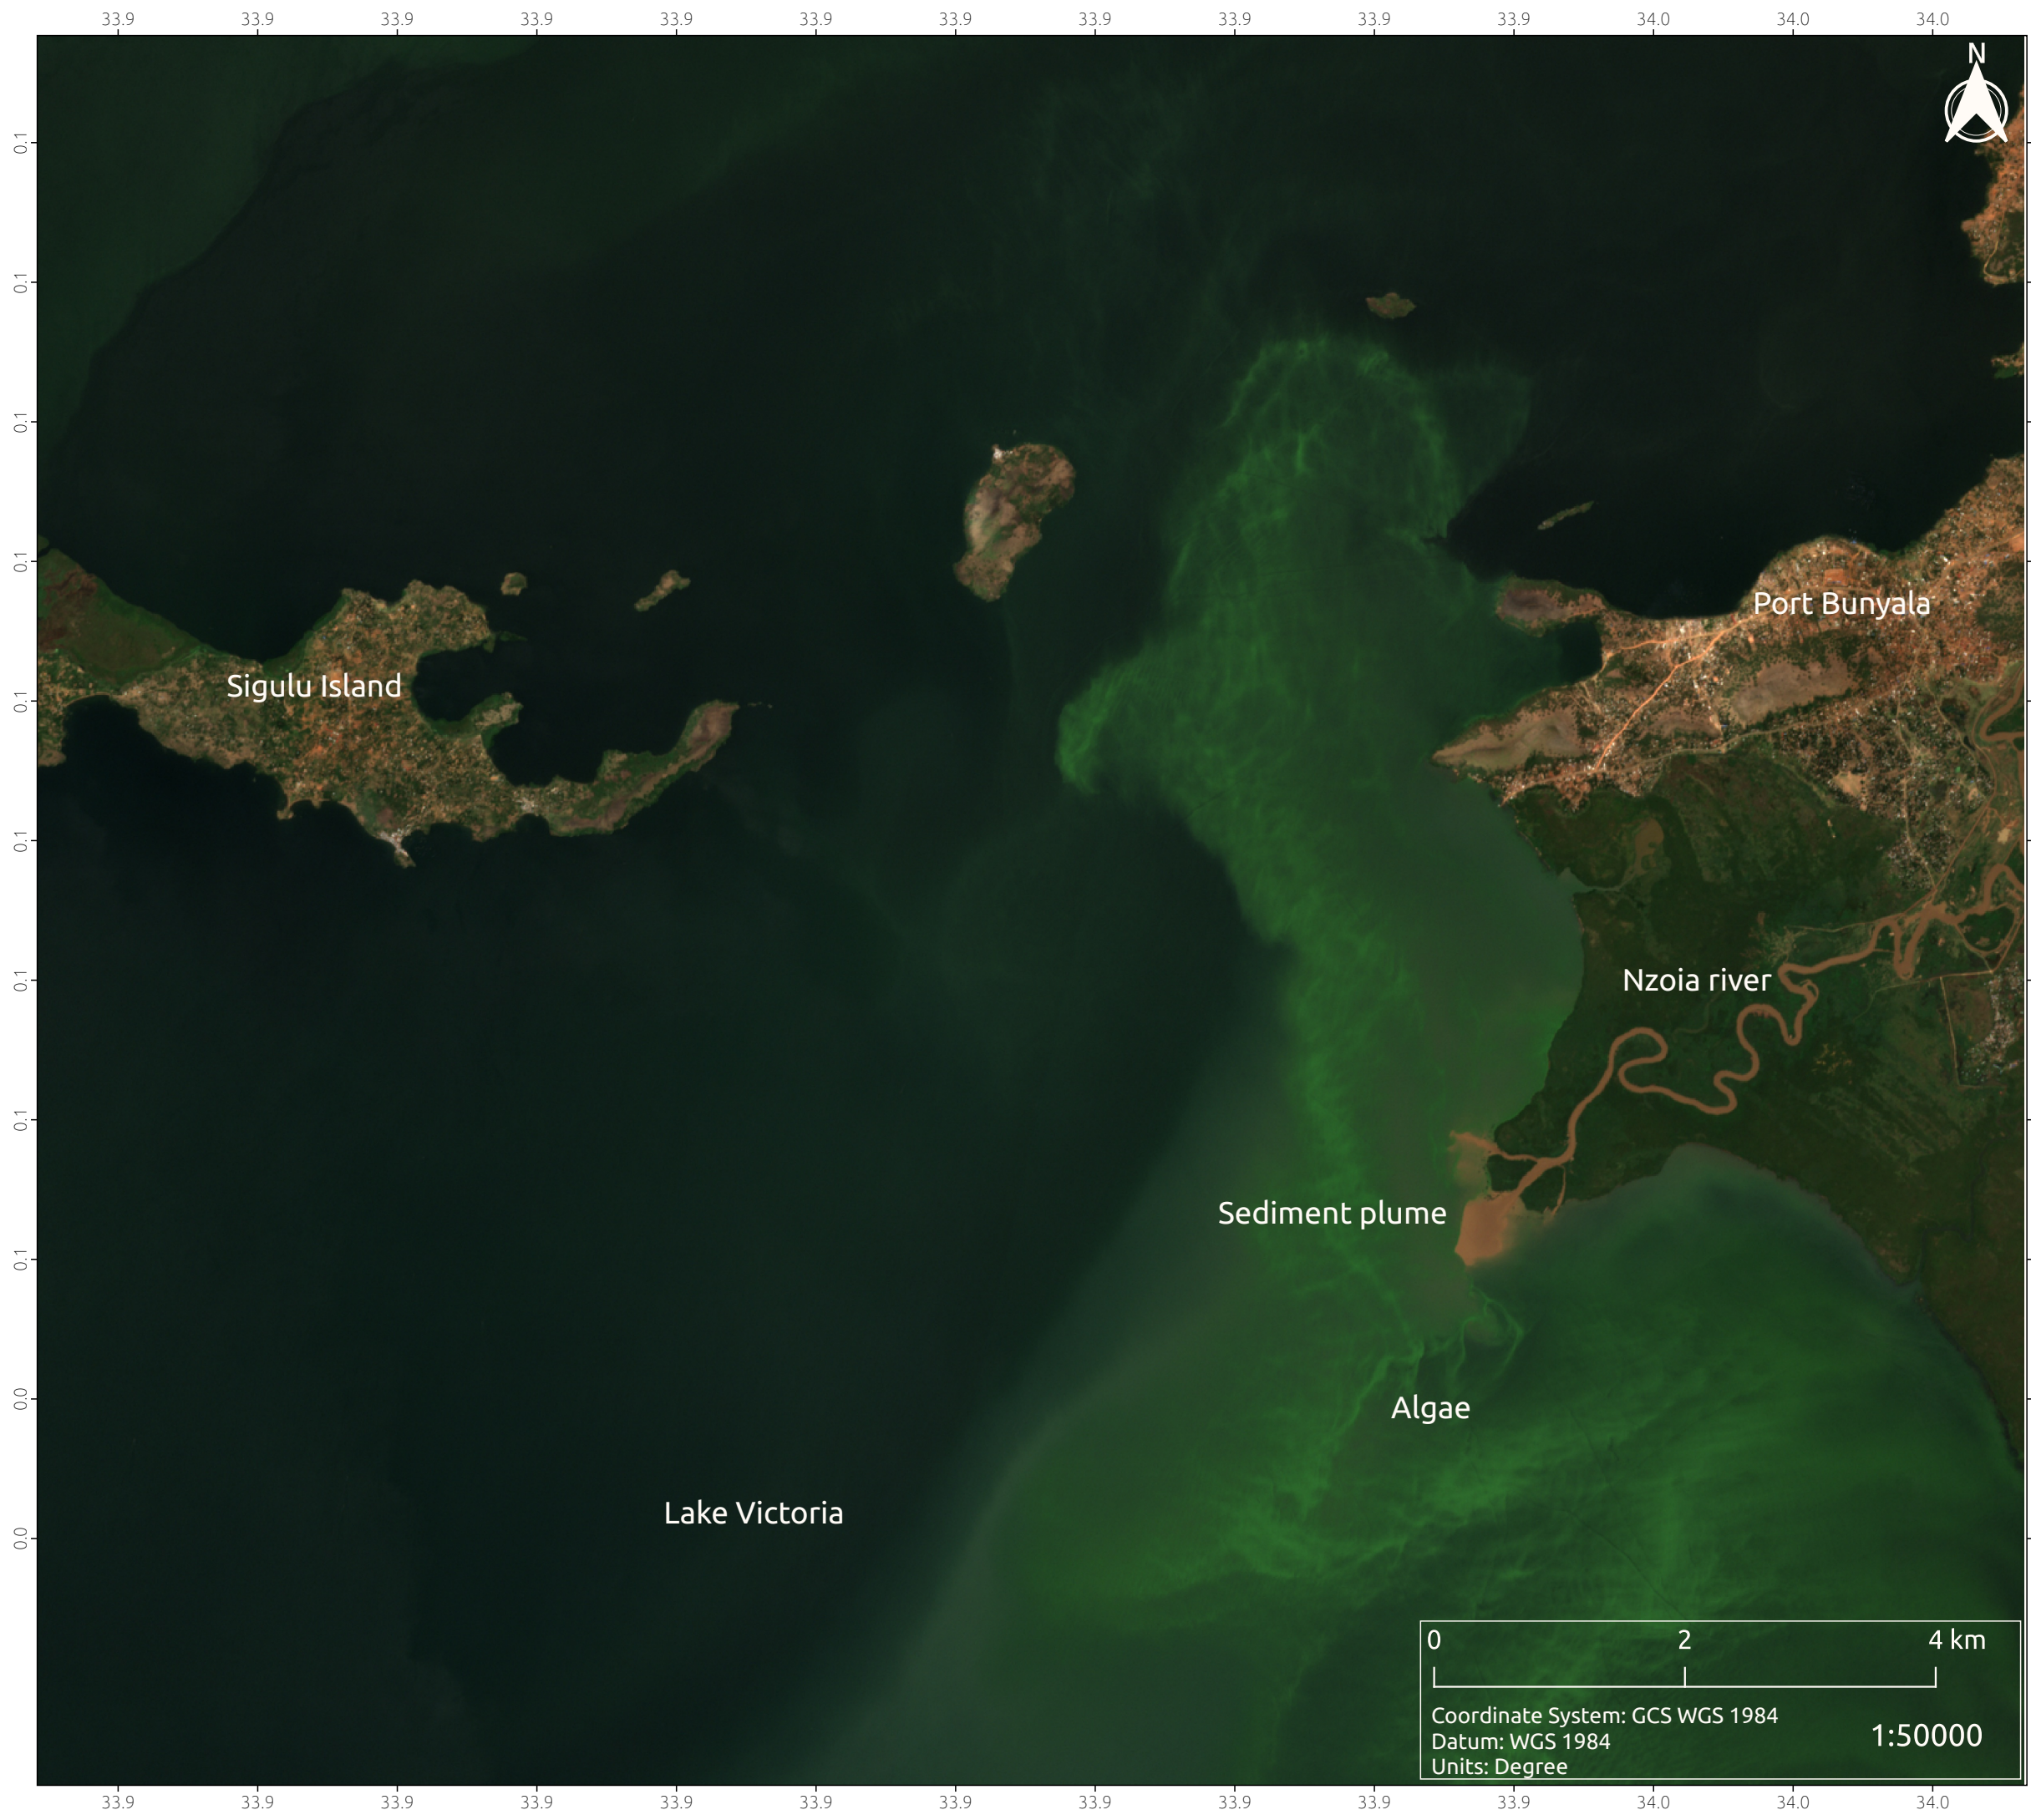
Sentinel 2 TC Image August 2021

These maps depict Nzoia river sediment plumes during various time steps in 2021. The true colour (TC) images are derived from Sentinel 2 satellite datasets. Sediment can carry pathogens, nutrients and other detrimental substances for the water quality of Lake Victoria.

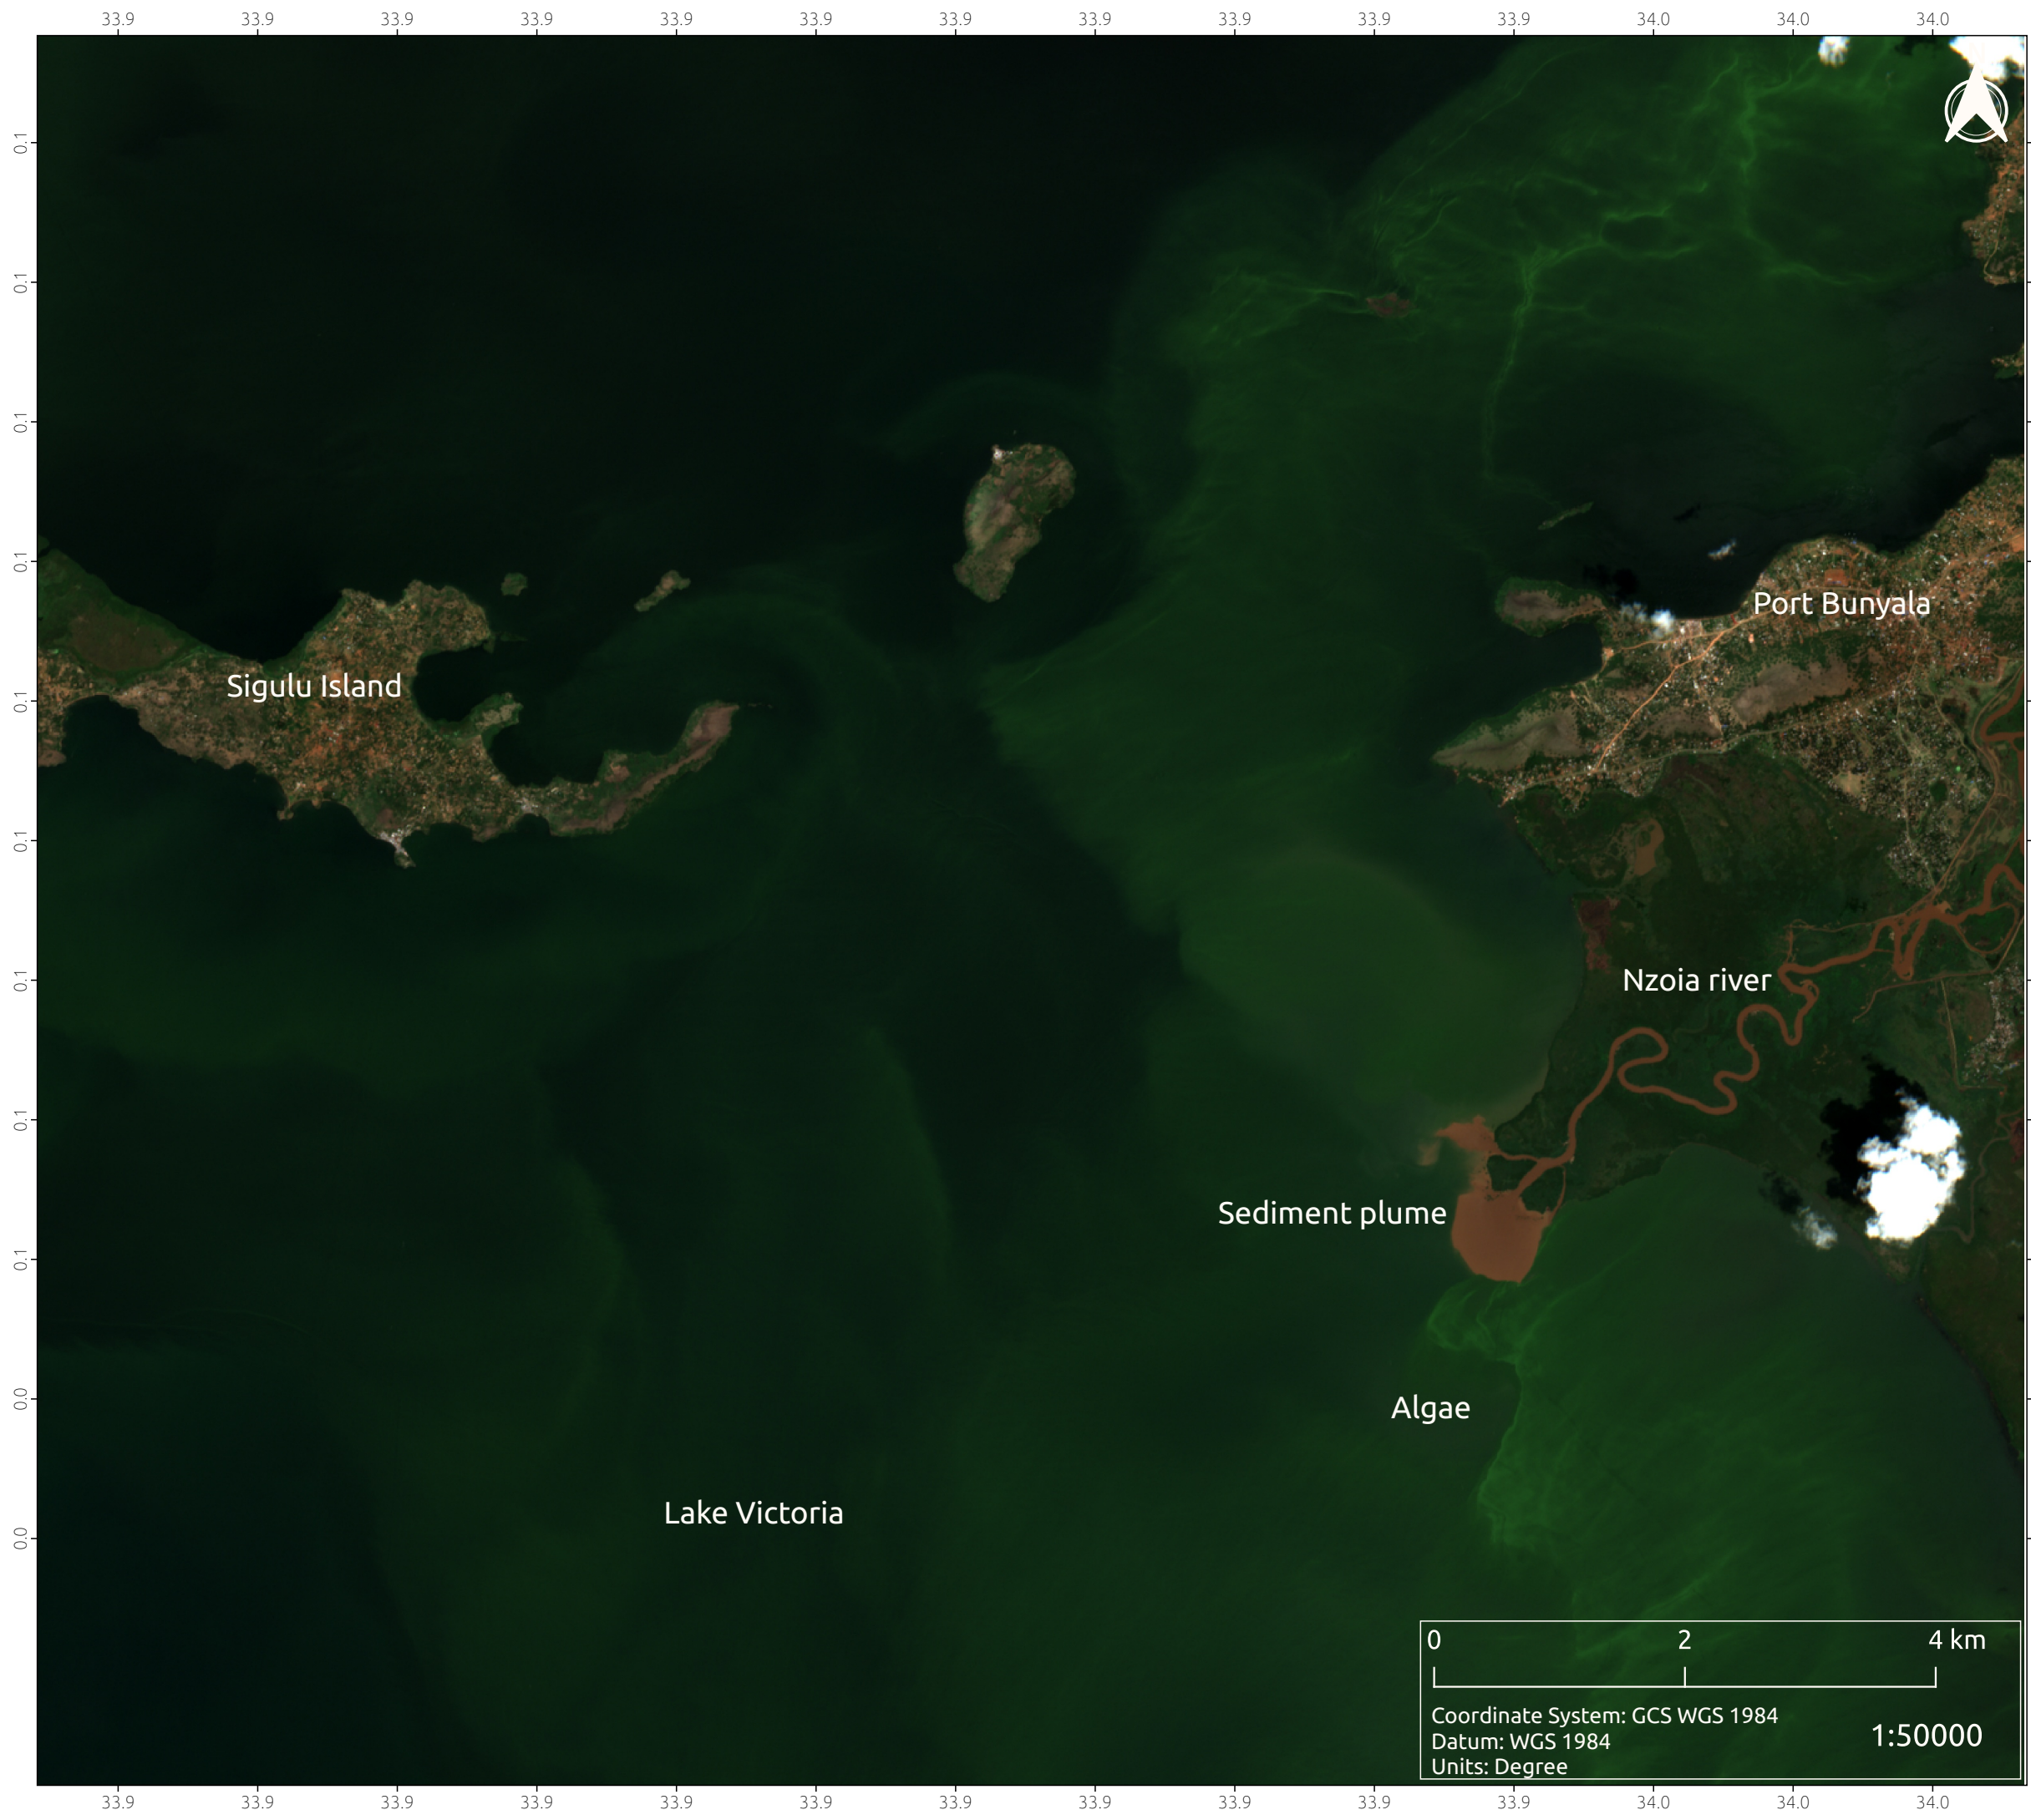
Sentinel 2 TC Image October 2021

These maps depict Nzoia river sediment plumes during various time steps in 2021. The true colour (TC) images are derived from Sentinel 2 satellite datasets. Sediment can carry pathogens, nutrients and other detrimental substances for the water quality of Lake Victoria.

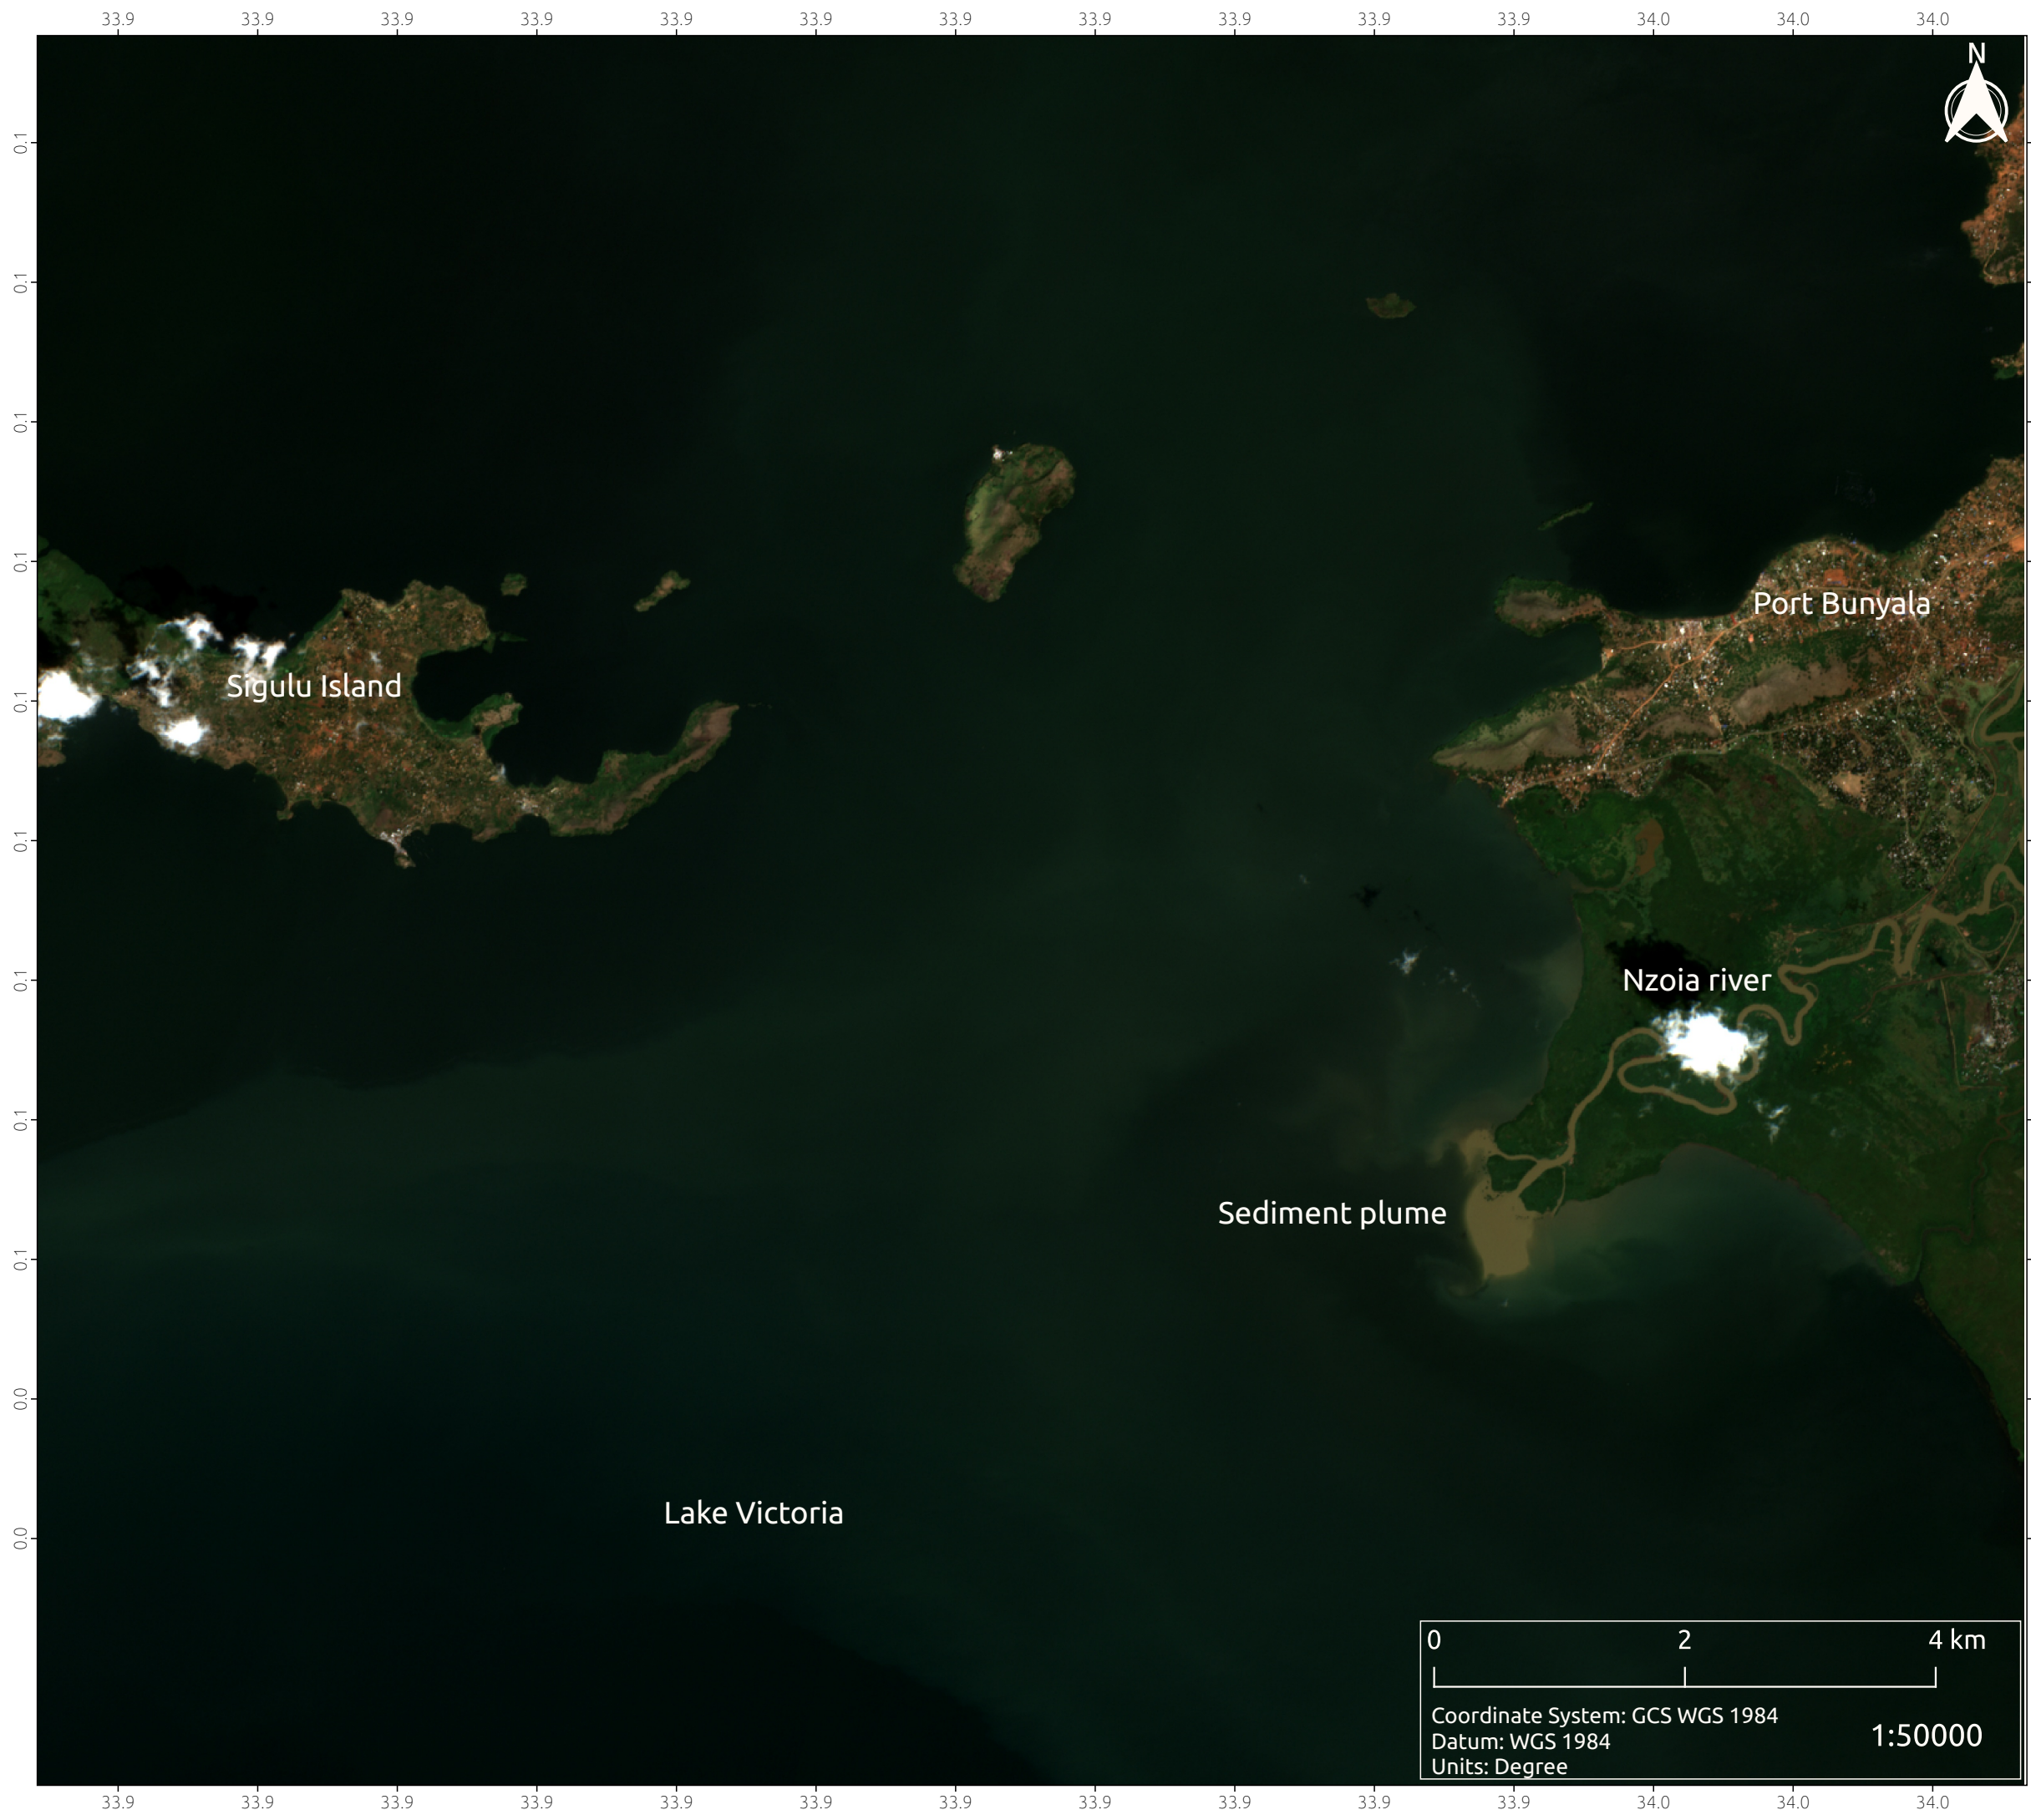
Sentinel 2 TC Image December 2021

These maps depict Nzoia river sediment plumes during various time steps in 2021. The true colour (TC) images are derived from Sentinel 2 satellite datasets. Sediment can carry pathogens, nutrients and other detrimental substances for the water quality of Lake Victoria.
